BUILDING
MATERIALS
AND
STRUCTURES
REPORT BMS32

Structural Properties of Two
Brick-Concrete-Block Wall Con-
structions and a Concrete-Block Wall
Construction Sponsored by the
National Concrete Masonry
Association

ISSUED NOVEMBER 2, 1939

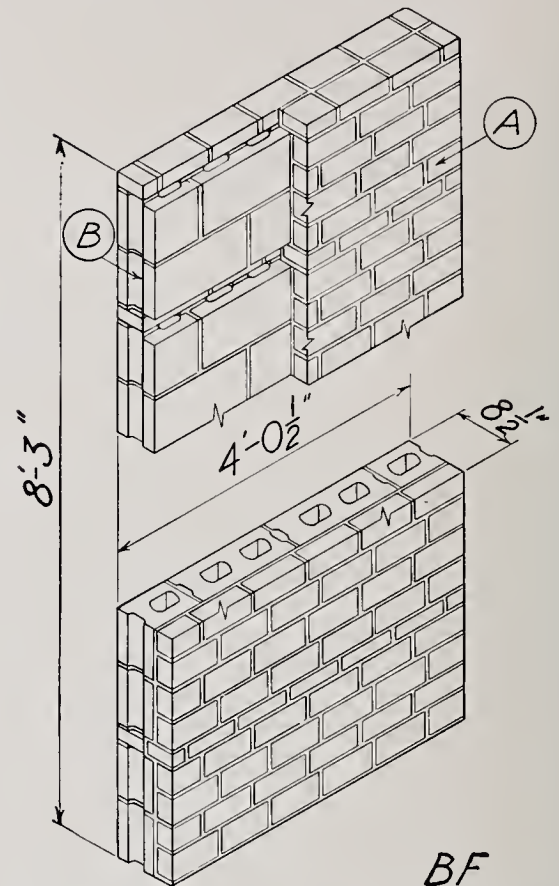
FIGURE 5.—Four-foot wall specimen BF, having top bonding course.

A, facing; *B*, backing.

The cost of this construction is less than that of the conventional brick-faced wall because less brick is required. For an 8-in. wall the backing unit is 6 in. thick, and for a 12-in. wall the backing unit is 10 in. thick. Time studies indicate that the labor cost for walls of this construction is somewhat less than for conventional brick-faced walls. It is recommended not only for low-cost houses but especially for churches, schools, and industrial buildings.

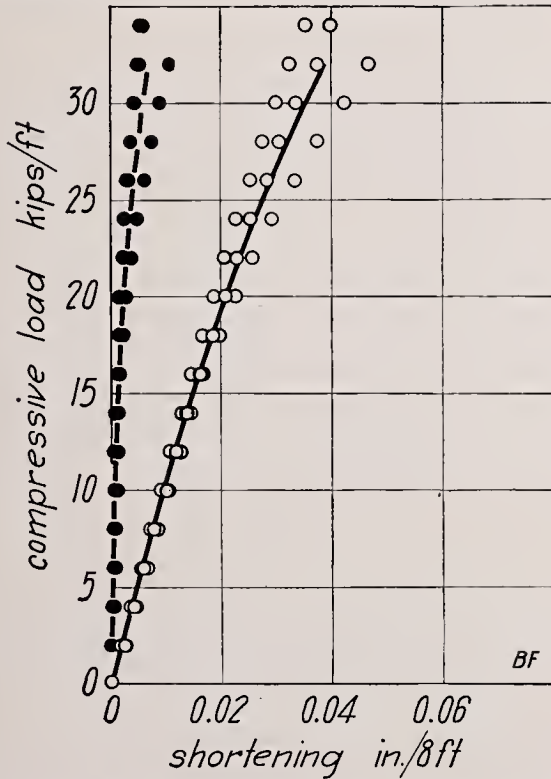
FIGURE 6.—Compressive load on wall BF.
Load-shortening (open circles) and load-set (solid circles) results for specimens BF-C1, C2, and C3. The load was applied 2.83 in. (one-third the thickness of the wall) from the inside face. The loads are in kips per foot of actual width of specimen.

The shortenings and sets for a height of 8 ft were computed from the values obtained from the compressometer readings. The compressometers were attached to the specimens, the gage length being 6 ft 7½ in.

Each of the specimens failed by crushing of the concrete units in the backing in two or three

courses at the upper end of the specimen. The mortar of the top bed joint in the backing of specimens C1 and C2 also crushed. In addition, in each of the specimens, the bond between the mortar and brick in the facing ruptured two or three courses from the upper end of the specimen.

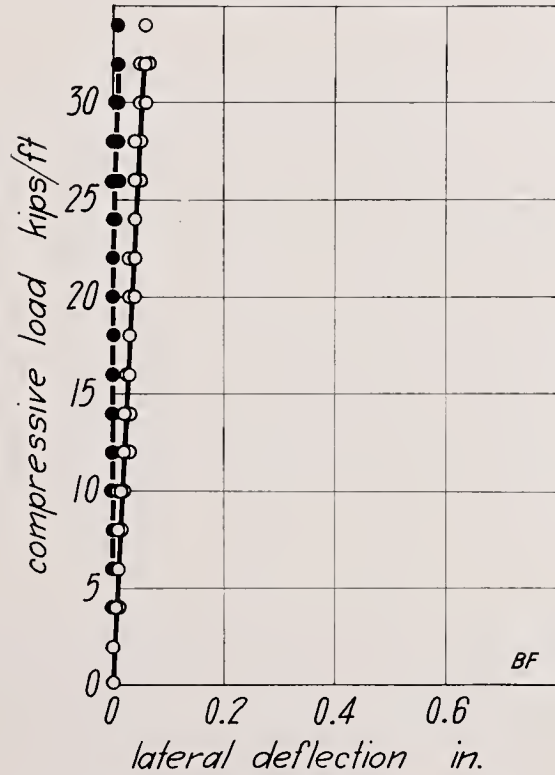
FIGURE 7.—Compressive load on wall BF.
Load-lateral deflection (open circles) and load-lateral set (solid circles) results for specimens BF-C1, C2, and C3. The load was applied 2.83 in. (one-third the thickness of the wall) from the inside face. The loads are in kips per foot of actual width of specimen. The deflections and sets are for a height of 6 ft 8 in., the gage length of the deflectometers.

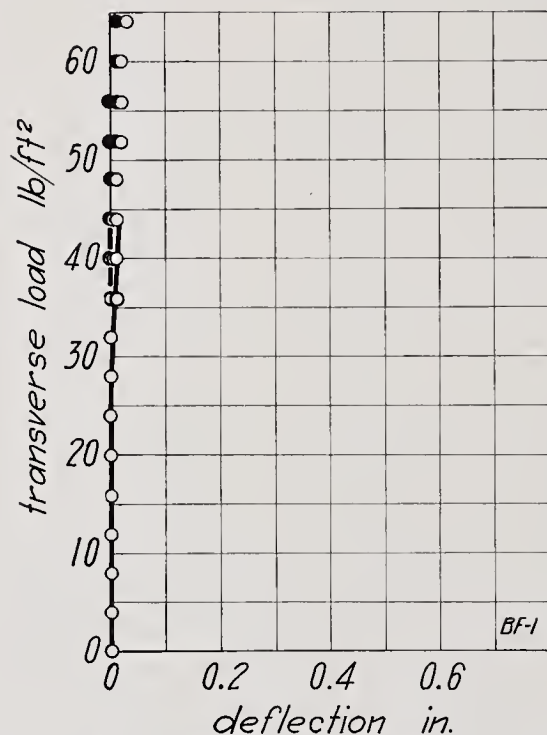
FIGURE 8.—Transverse load on wall BF, load applied to inside face.

Load-deflection (open circles) and load-set (solid circles) results for specimens BF-T1, T2, T3 on the span 7 ft 6 in. The deflections and sets are for a gage length of 7 ft 4 in., the gage length of the deflectometers.

At the maximum load each of the specimens T1, T2, and T3 failed by rupture of the bond between the mortar and a brick bonding course in the facing at one or two bed joints at or be-

tween the loading rollers. In specimen T2 the rupture extended through the backing also.

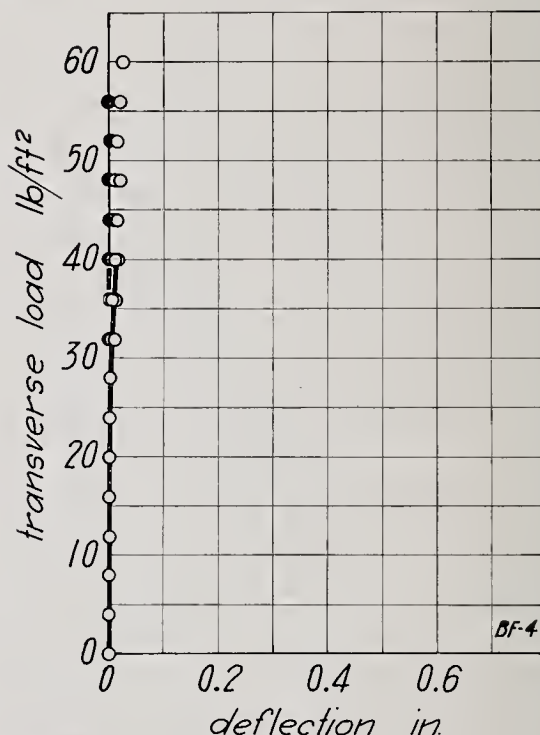
FIGURE 9.—Transverse load on wall BF, load applied to outside face.

Load-deflection (open circles) and load-set (solid circles) results for specimens BF-T4, T5, and T6 on the span 7 ft 6 in. The deflections and sets are for a gage length of 7 ft 4 in., the gage length of the deflectometers.

At the maximum load each of the specimens T4, T5, and T6 failed by rupture of the bond between the mortar and the concrete units at a bed joint in the backing at or between the loading rollers. In specimen T4 the rupture occurred at a bonding course; in specimens T5 and T6 the rupture extended through the facing also.

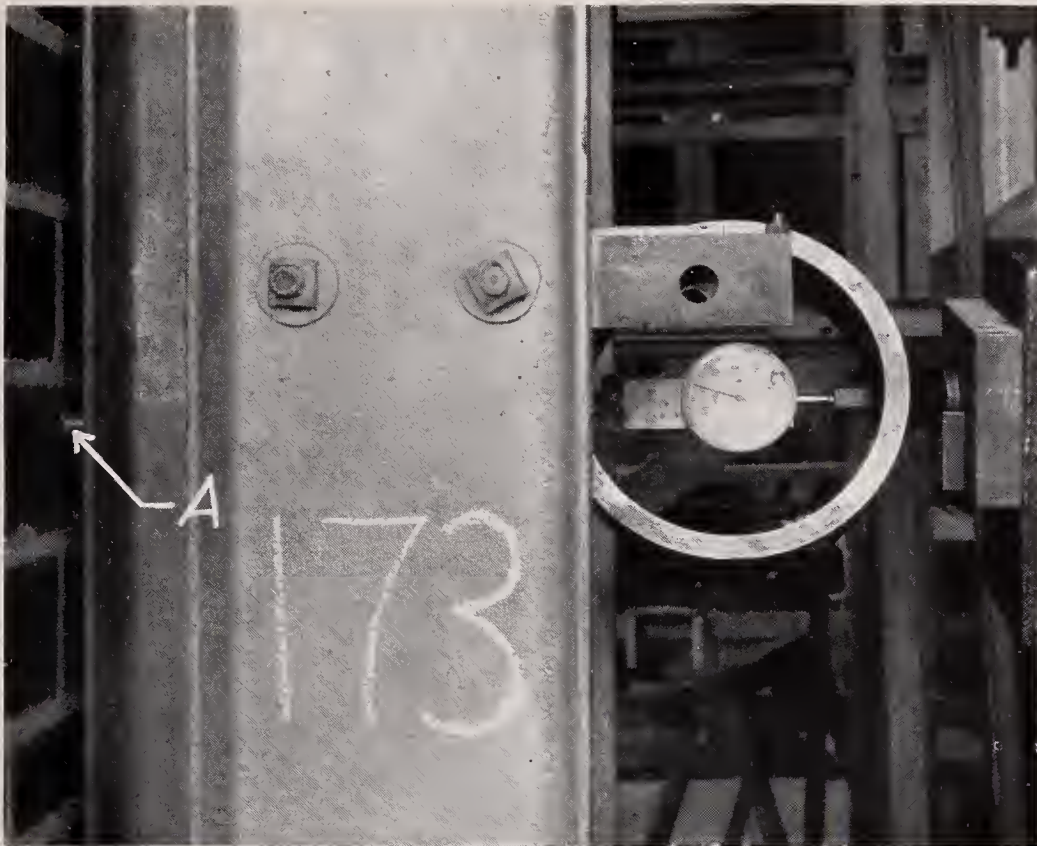
FIGURE 10.—Wall specimen BF-P5 under concentrated load.
A, loading disk.

Wall specimen BF-P5 under concentrated load is shown in figure 10. The results are shown in table 7 and in figure 11 for wall specimens BF-P1, P2, and P3, loaded on the inside face, and in figure 12 for wall specimens BF-P4, P5, and P6, loaded on the outside face.

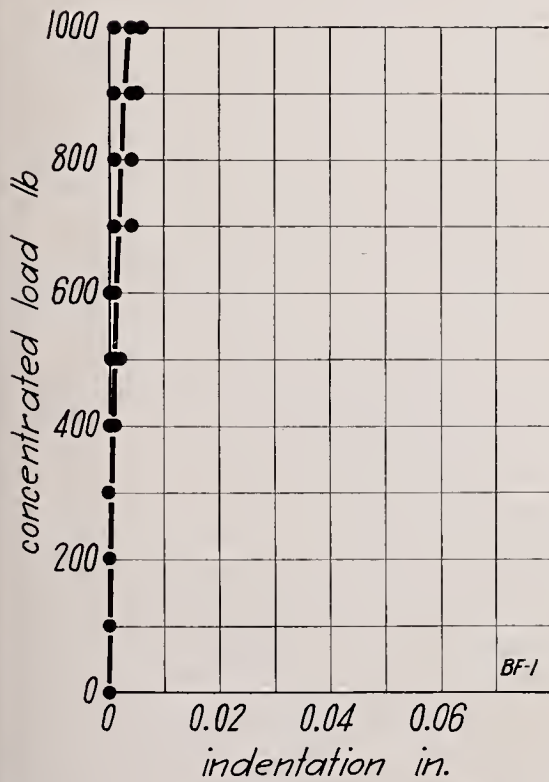
FIGURE 11.—Concentrated load on wall BF,
load applied to inside face.
Load-indentation results for specimens BF-P1, P2, and P3.

The concentrated loads were applied over the center web of a concrete block of specimens

P1 and P3 and over one cell of a concrete block of specimen P2. In specimens P1, P2, and P3, the indentations after a load of 1,000 lb had been applied were 0.006, 0.001, and 0.004 in., respectively, and no other effect was observed.

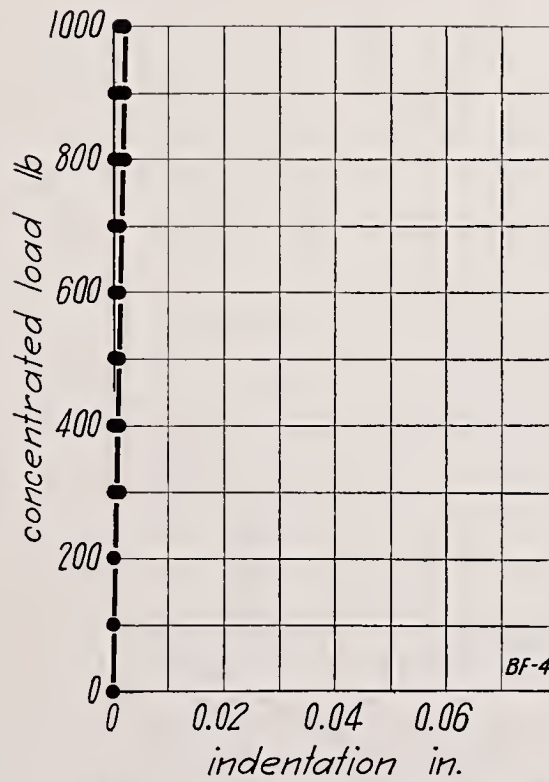
FIGURE 12.—Concentrated load on wall BF,
load applied to outside face.
Load-indentation results for specimens BF-P4, P5,
and P6.

The concentrated loads were applied to a brick in a bonding course of specimens *P4* and *P5* and to a brick in a rowlock course of specimen *P6*. In specimens *P4*, *P5*, and *P6*, the indentations after a load of 1,000 lb had been applied were 0.002, 0.001, and 0.001 in., respectively, and no other effect was observed.

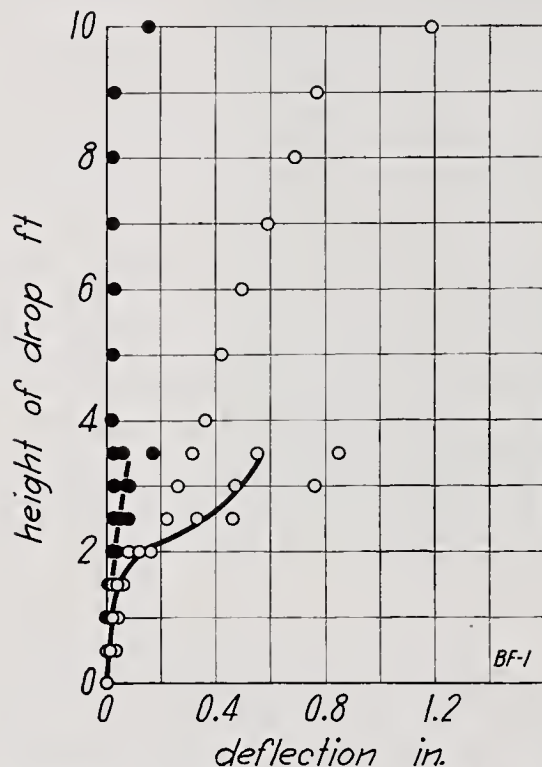
FIGURE 13.—Impact load on wall BF, load applied to inside face.

Height of drop-deflection (open circles) and height of drop-set (solid circles) results for specimens BF-11, 12, and 13 on the span 7 ft 6 in.

In each of the specimens 11, 12, and 13 at drops of 2.5, 2, and 2 ft, respectively, the bond between the mortar and the brick ruptured at a bed joint in the facing near midspan. At drops of 3, 3, and 4.5 ft, respectively, the bond between the mortar and the concrete units ruptured at a bed joint in the backing at about the same height as the cracks in the facing. At the maximum drop each of these specimens failed by opening of these cracks or by rupture of

other bed joints. The failure of specimen 13 occurred at a bonding course.

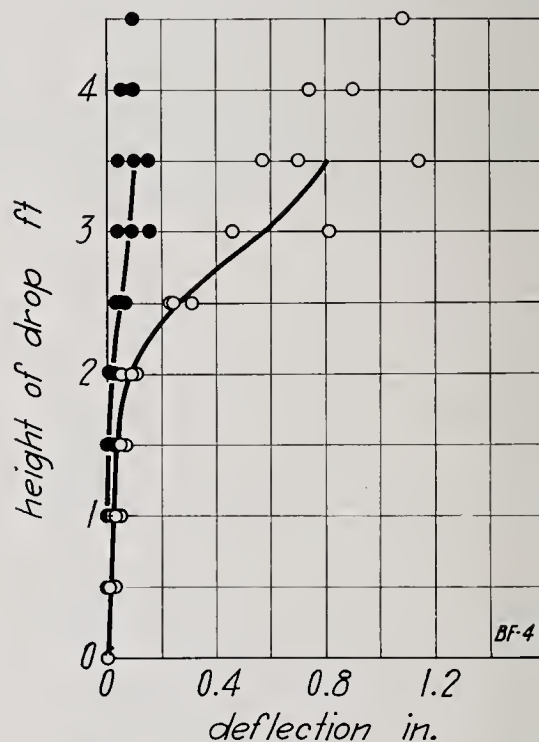
FIGURE 14.—Impact load on wall BF, load applied to outside face.

Height of drop-deflection (open circles) and height of drop-set (solid circles) results for specimens BF-14, 15, and 16 on the span 7 ft 6 in.

In each of the specimens 14, 15, and 16 at a drop of 2 ft the bond between the mortar and the concrete units ruptured at a bed joint in the backing near midspan. At drops of 3, 3, and 2.5 ft, respectively, the bond between the mortar and the brick ruptured at a bed joint in the facing at the same height. At the maximum drop each specimen failed by opening of these cracks. The failure of specimen 16 occurred at a bonding course.

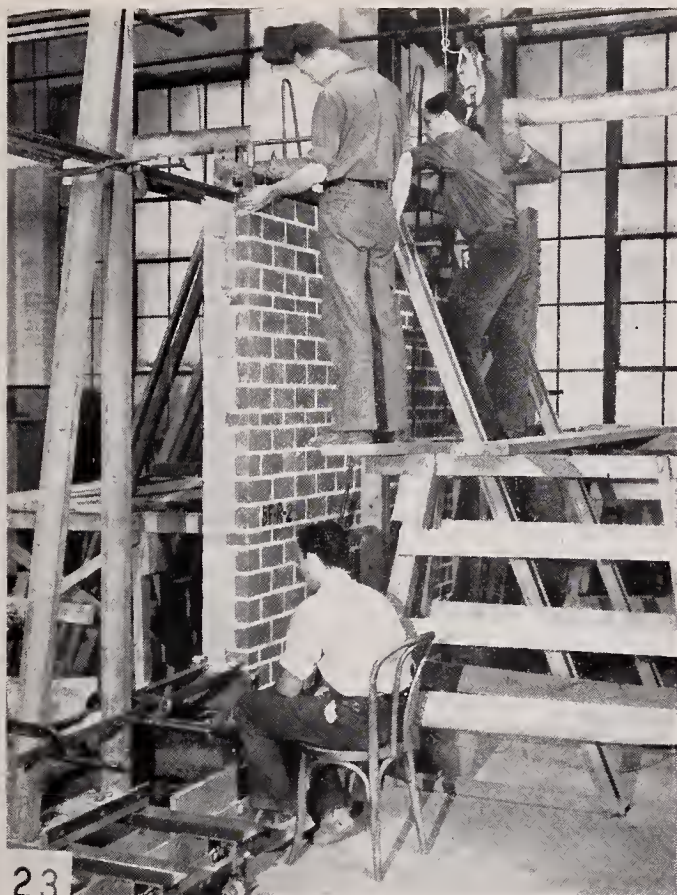
FIGURE 15.—Wall specimen BF-R2 under racking load.

Wall specimen BF-R2 under racking load is shown in figure 15. The results for wall speci-

Specimens *R1* and *R2* failed by rupture of the bond between the mortar and blocks in the backing and the mortar and brick in the facing in stepwise cracks in the bed and head joints diagonally from the load to the stop. Some bricks and blocks also broke. Specimen *R3* did not fail; the set after a load of 6.15 kips/ft had been applied was 0.007 in., and no other effect was observed.

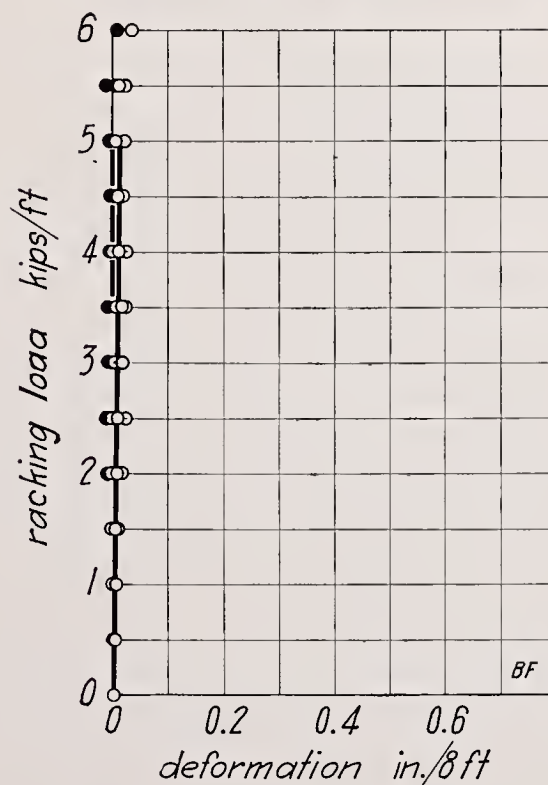
FIGURE 16.—Racking load on wall BF.

Load-deformation (open circles) and load-set (solid circles) results for specimens BF-R1, R2, and R3. The loads are in kips per foot of actual width of specimen.

The deformations and sets shown in figure 16 were computed from the measuring-device readings. The gage length of the vertical measuring device was 6 ft 7½ in. The gage length of the horizontal measuring device was 5 ft 0 in.

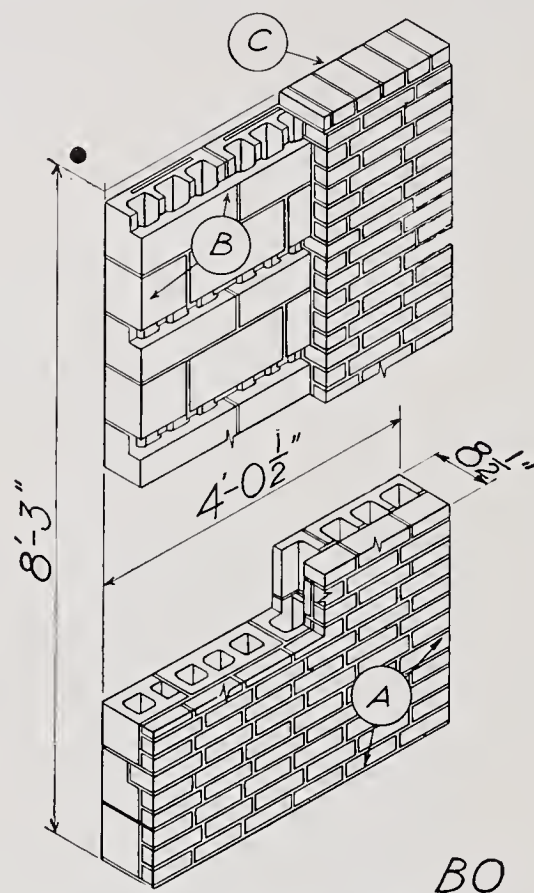
FIGURE 17.—Four-foot wall specimen *BO*, having top header course.

A, facing; B, backing; C, header course.

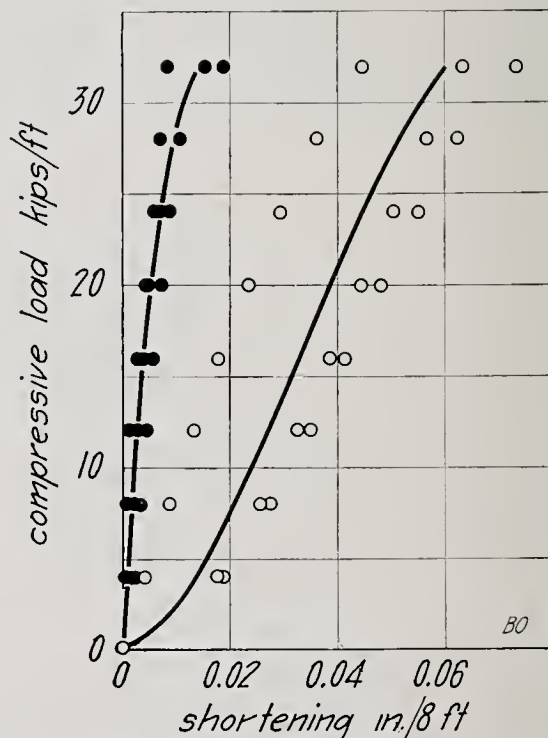
FIGURE 18.—Compressive load on wall *BO*.

Load-shortening (open circles) and load-set (solid circles) results for specimens *BO-C1*, *C2*, and *C3*. The load was applied 2.83 in. (one-third the thickness of the wall) from the inside face. The loads are in kips per foot of actual width of specimens.

Each of the specimens failed by crushing of the concrete blocks in the backing in two or

three courses at the upper end of the specimen. In specimen *C3* the bond between the mortar and brick ruptured in a course near the upper end of the specimen.

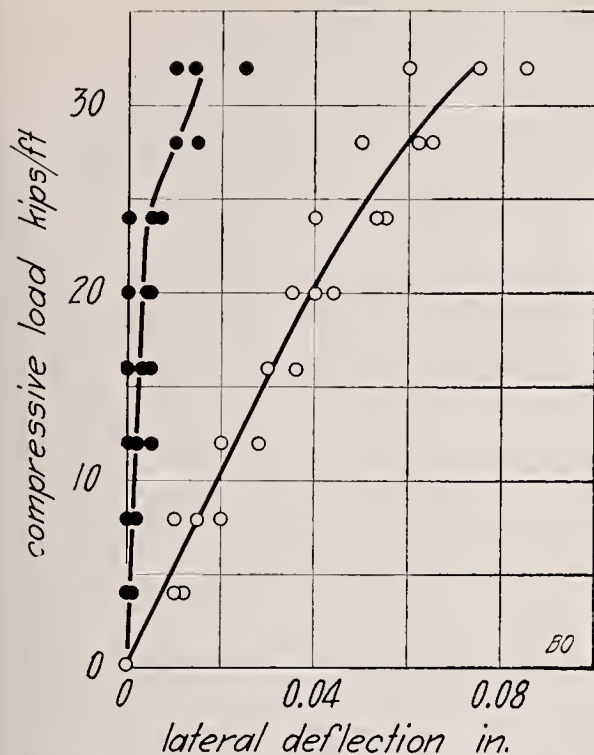
FIGURE 19.—Compressive load on wall BO.

Load-lateral deflection (open circles) and load-lateral set (solid circles) results for specimens BO-C1, C2, and C3. The load was applied 2.83 in. (one-third the thickness of the wall) from the inside face. The loads are in kips per foot of actual width of specimen. The deflections and sets are for a height of 7 ft 8 in., the gage length of the deflectometers.

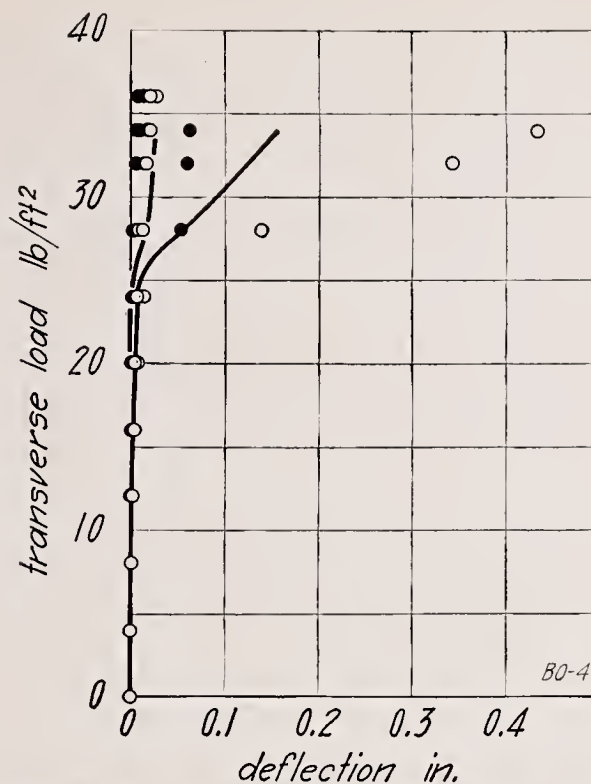
FIGURE 21.—Transverse load on wall BO, load applied to outside face.

Load-deflection (open circles) and load-set (solid circles) results for specimens BO-T4, T5, and T6 on the span 7 ft 6 in. The deflections and sets are for a gage length of 7 ft 6 in., the gage length of the deflectometers.

The results are shown in table 7 and in figure 20 for wall specimens *BO-T1*, *T2*, and *T3*, loaded on the inside face, and in figure 21 for wall specimens *BO-T4*, *T5*, and *T6*, loaded on the outside face.

Each of the specimens *T1*, *T2*, *T3*, *T4*, and *T6* failed by rupture of the bond between the mortar and brick at a bed joint in the facing and between the mortar and concrete blocks at a bed joint in the backing at or between the loading rollers. The break appeared first in the face opposite the load and then extended to the loaded face. In specimen *T5* at a load of 28

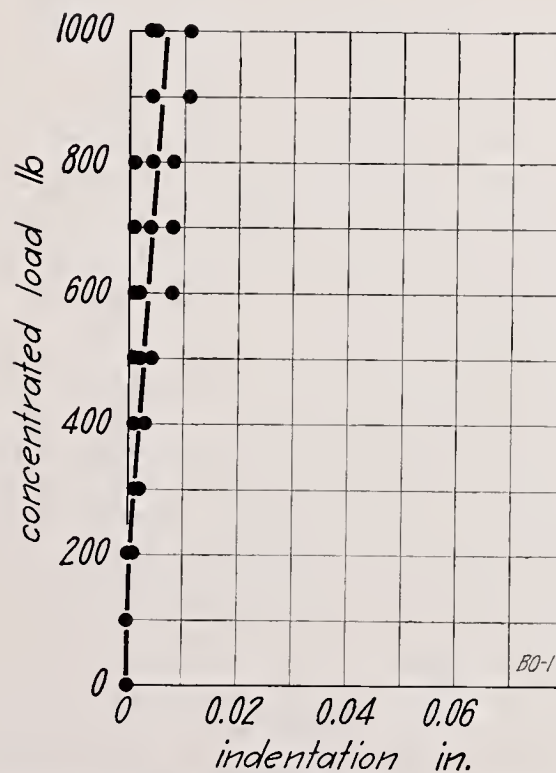
FIGURE 22.—Concentrated load on wall BO, load applied to inside face.

Load-indentation results for specimens BO-P1, P2, and P3.

The concentrated loads were applied over one cell of a concrete block of specimens P1, P2, and P3, and on a split brick of specimens P4, P5, and P6. In specimens P1, P2, P3, P4, P5, and P6, the indentations after a load of 1,000 lb had been applied were 0.011, 0.004, 0.005, 0.006, 0.000, and 0.003 in., respectively, and no other effect was observed.

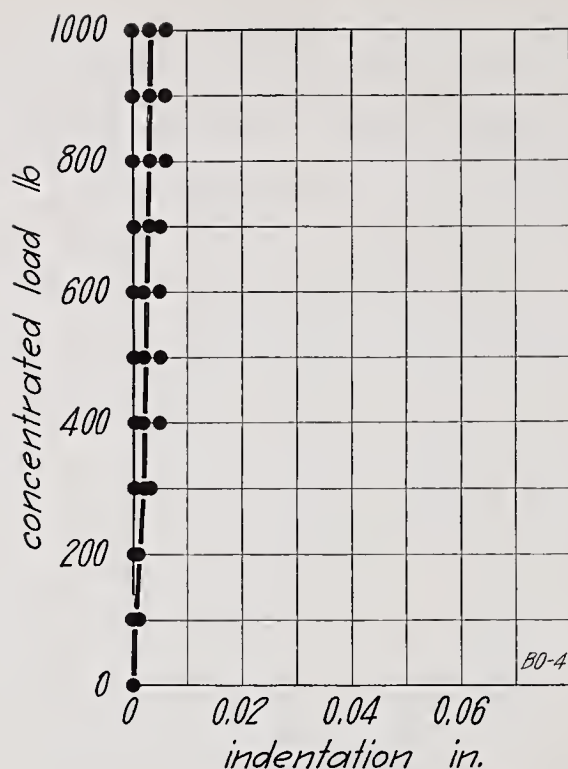
FIGURE 23.—Concentrated load on wall BO, load applied to outside face.

Load-indentation results for specimens BO-P4, P5, and P6.

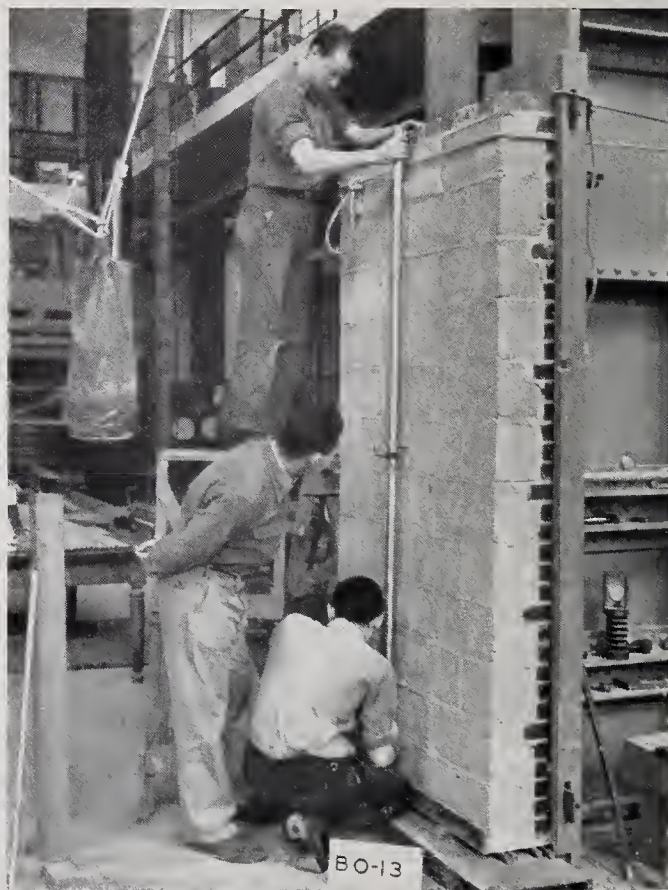
FIGURE 24.—Wall specimen BO-I3 during the impact test.

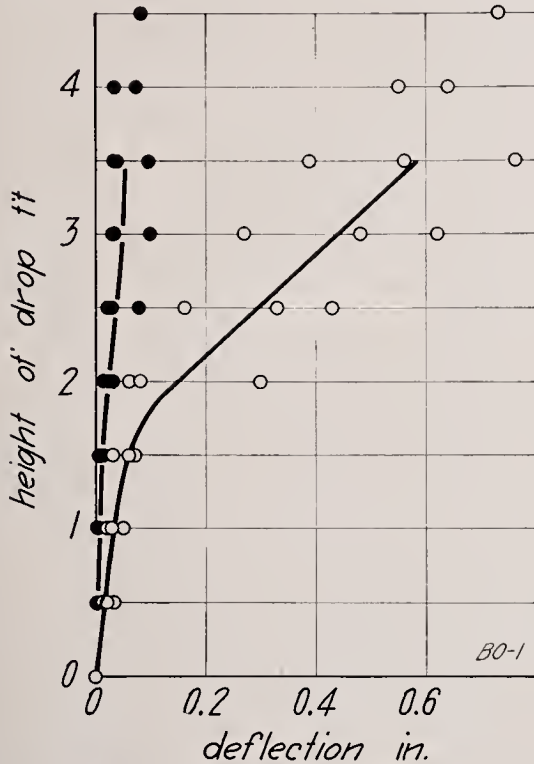
FIGURE 25.—Impact load on wall *BO*, load applied to inside face.

Height of drop-deflection (open circles) and height of drop-set (solid circles) results for specimens *BO-I1*, *I2*, and *I3* on the span 7 ft 6 in.

In specimens I1, I2, and I3 at drops of 2.5, 4, and 2 ft, respectively, the bond between the mortar and brick ruptured at a bed joint in the facing near midspan. At drops of 3, 4.5, and 3 ft, respectively, the bond between the mortar and concrete blocks ruptured at a bed joint in the backing near midspan. At the maximum drops the specimens failed by opening of these cracks.

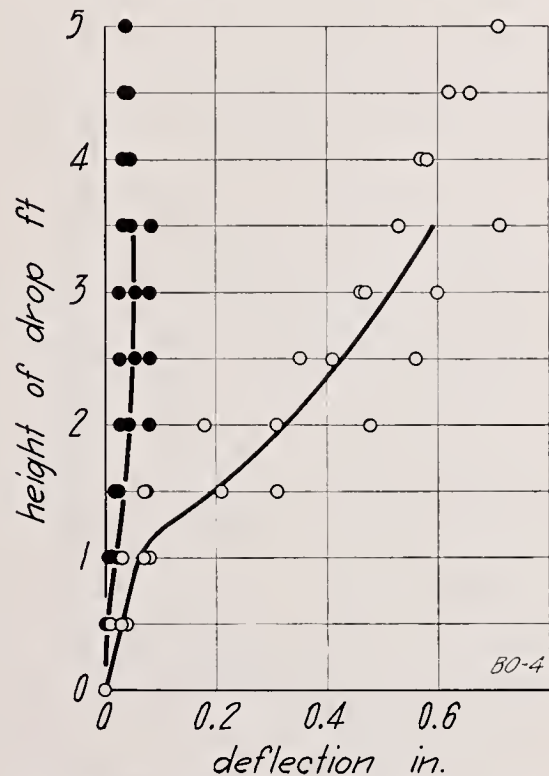
FIGURE 26.—Impact load on wall *BO*, load applied to outside face.

Height of drop-deflection (open circles) and height of drop-set (solid circles) results for specimens *BO-I4*, *I5*, and *I6*, on the span 7 ft 6 in.

In specimens I4, I5, and I6 at drops of 1.5, 2, and 1.5 ft, respectively, the bond between the mortar and concrete blocks ruptured at a bed joint in the backing near midspan. At drops of 2.5, 3, and 3 ft, respectively, the bond between the mortar and brick ruptured at a bed joint in the facing near midspan. At the maximum drops the specimens failed by opening of these cracks.

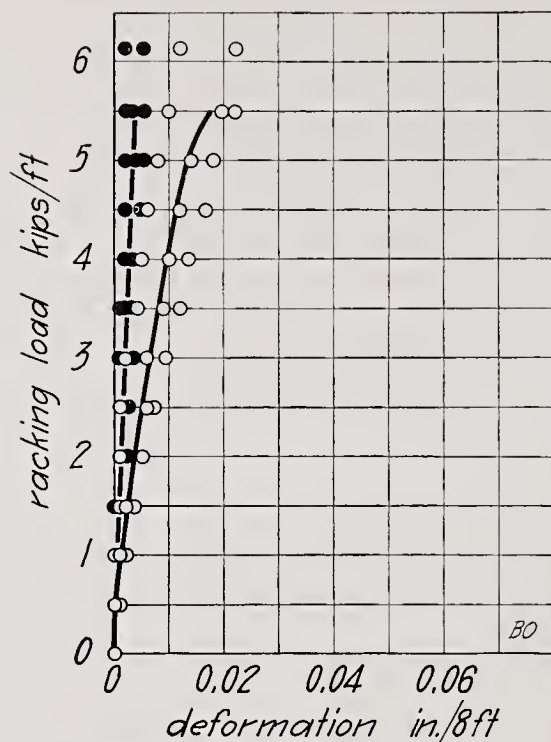
FIGURE 27.—Racking load on wall BO.

Load-deformation (open circles) and load-set (solid circles) results for specimens BO-R1, R2, and R3. The loads are in kips per foot of actual width of specimen.

The results for wall specimens *BO-R1*, *R2*, and *R3* are shown in table 7 and in figure 27.

The deformations and sets shown in figure 27 were computed from the measuring-device

Specimen *R1* failed by rupture of the bed and head joints of both the facing and the backing in stepwise cracks diagonally from the loaded corner to the stop. Some brick and concrete blocks also broke. Specimens *R2* and *R3* did not fail; the sets after a load of 6.13 kips/ft had been applied were 0.002 and 0.005 in., respectively, and no other effect was observed.

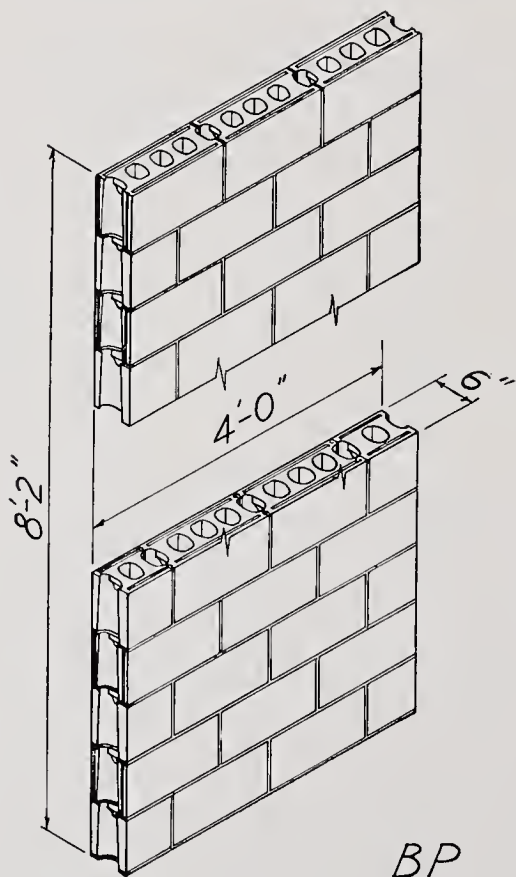
FIGURE 28.—Four-foot wall specimen BP.

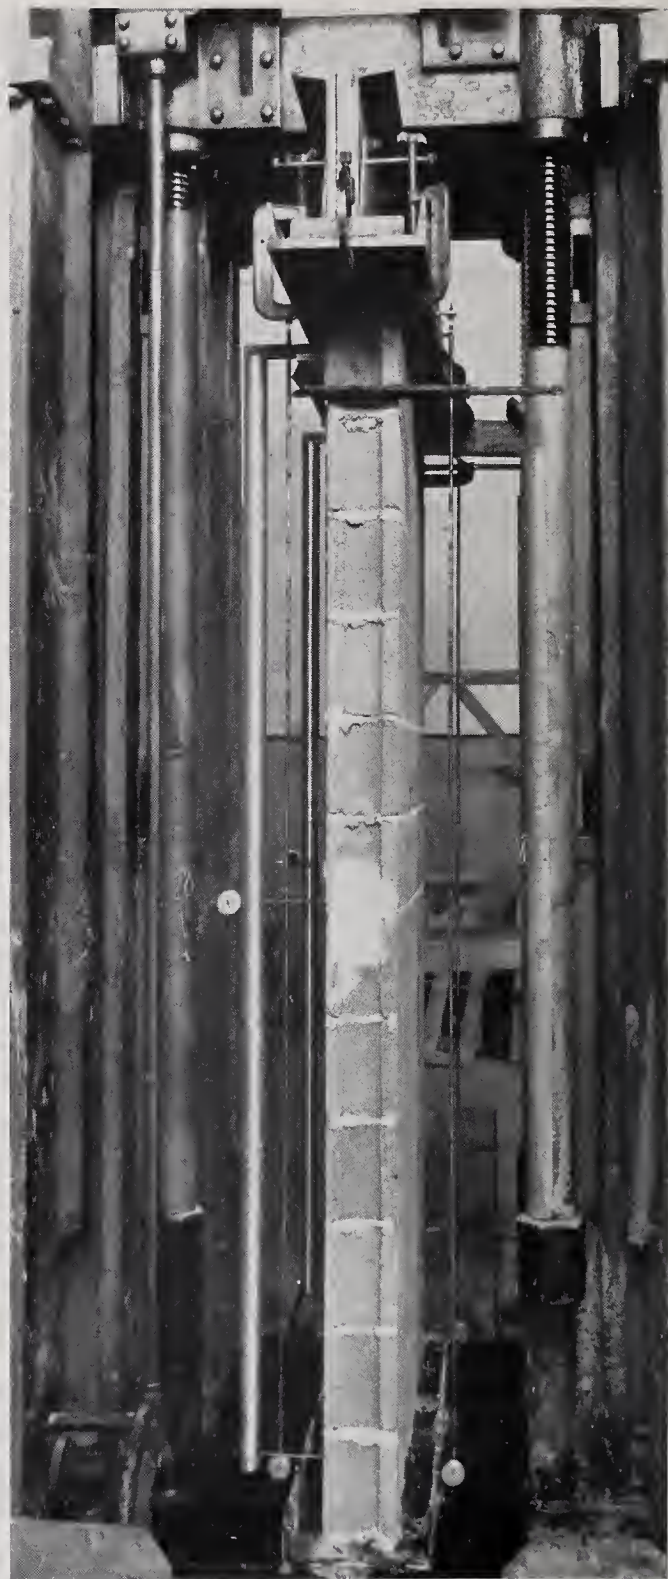
FIGURE 29.—Wall specimen BP-C2 under compressive load.

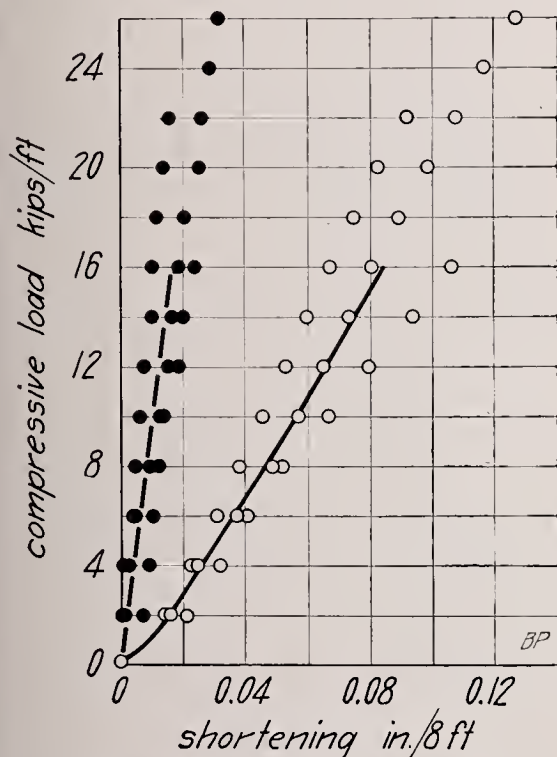
FIGURE 30.—Compressive load on wall BP.

Load-shortening (open circles) and load-set (solid circles) results for specimens *BP-C1*, *C2*, and *C3*. The load was applied 2.00 in. (one-third the thickness of the wall) from the inside face. The loads are in kips per foot of actual width of specimen.

The shortenings and sets shown in figure 30 for a height of 8 ft were computed from the values obtained from the compressometer readings. The compressometers were attached to the upper and lower bearing plates, the gage length being 8 ft 3 in.

Each of the specimens failed by crushing of from two to four of the top courses and vertical cracking of the concrete blocks in these courses.

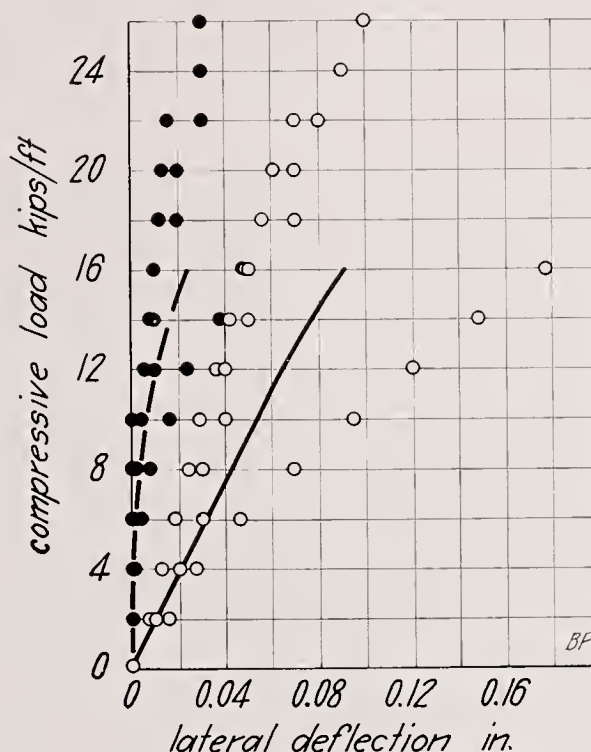
FIGURE 31.—Compressive load on wall BP.

Load-lateral deflection (open circles) and load-lateral set (solid circles) results for specimens *BP-C1*, *C2*, and *C3*. The load was applied 2.00 in. (one-third the thickness of the wall) from the inside face. The loads are in kips per foot of actual width of specimen. The deflections and sets are for a length of 7 ft 6 in., the gage length of the deflectometers.

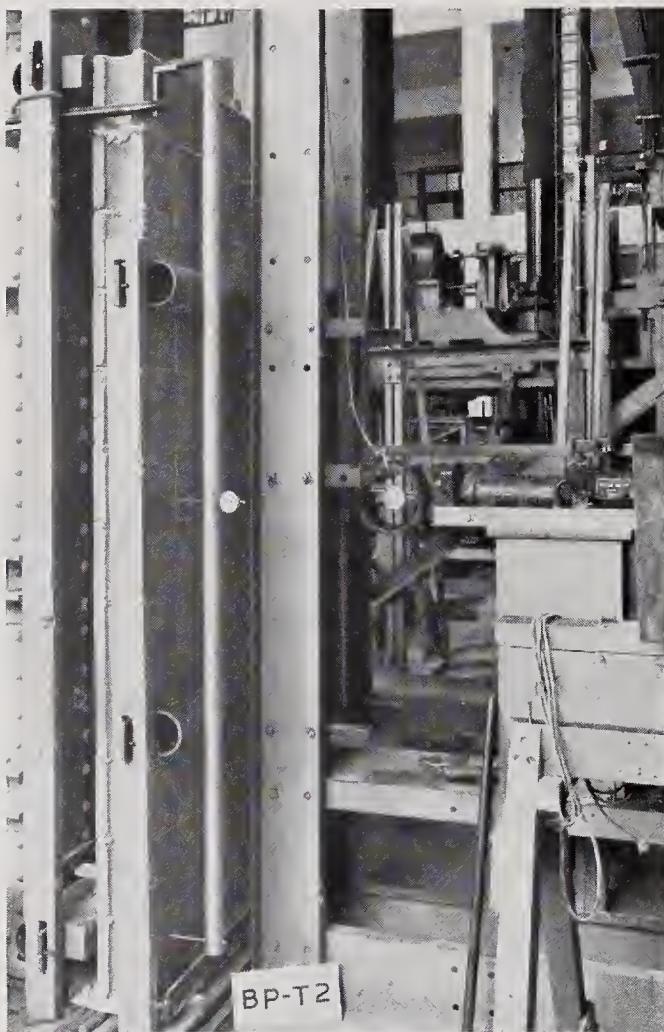
FIGURE 32.—Wall specimen *BP-T2* under transverse load.

Wall specimen *BP-T2* under transverse load is shown in figure 32. The results for wall specimens *BP-T1*, *T2*, and *T3* are shown in table 7 and in figure 33.

Each specimen failed by rupture of the bond between the mortar and the concrete blocks in a bed joint near the upper loading roller.

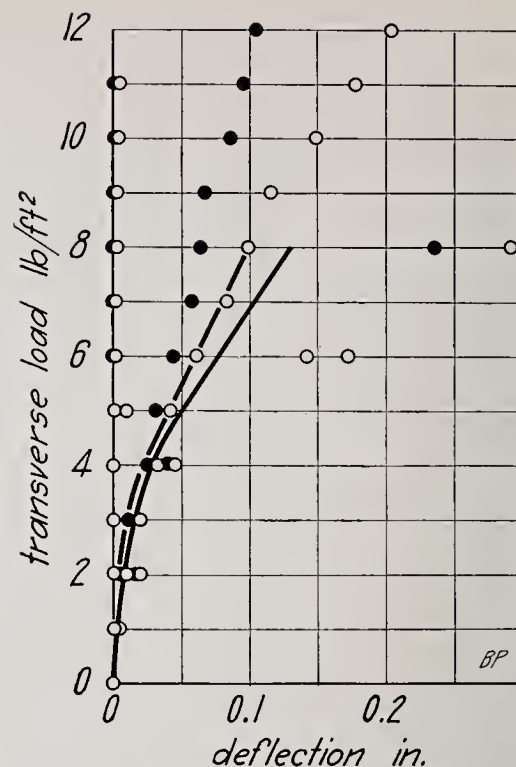
FIGURE 33.—Transverse load on wall *BP*. Load-deflection (open circles) and load-set (solid circles) results for specimens *BP-T1*, *T2*, and *T3* on the span 7 ft 6 in. The deflections and sets are for a length of 7 ft 6 in., the gage length of the deflectometers.

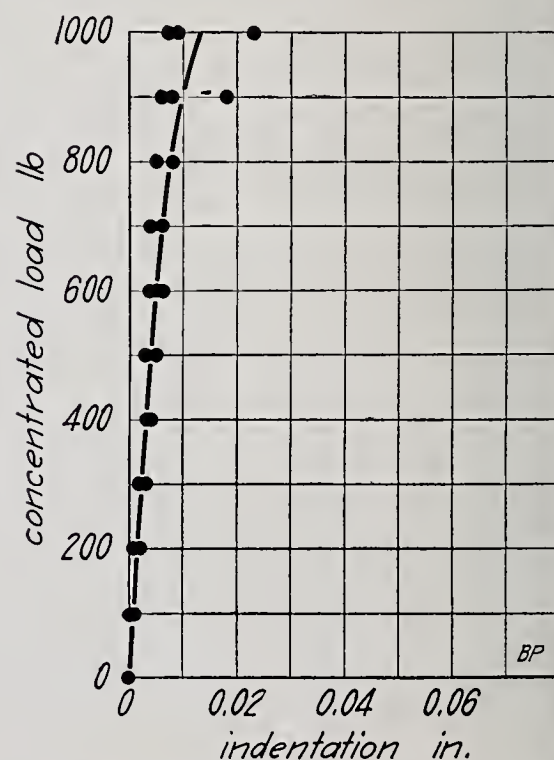
FIGURE 34.—Concentrated load on wall *BP*. Load-indentation results for specimens *BP-P1*, *P2*, and *P3*.

The concentrated loads were applied to each specimen over one cell of a concrete block. In specimens *P1*, *P2*, and *P3* the indentations after a load of 1,000 lb had been applied were 0.023, 0.009, and 0.007 in., respectively, and no other effect was observed.

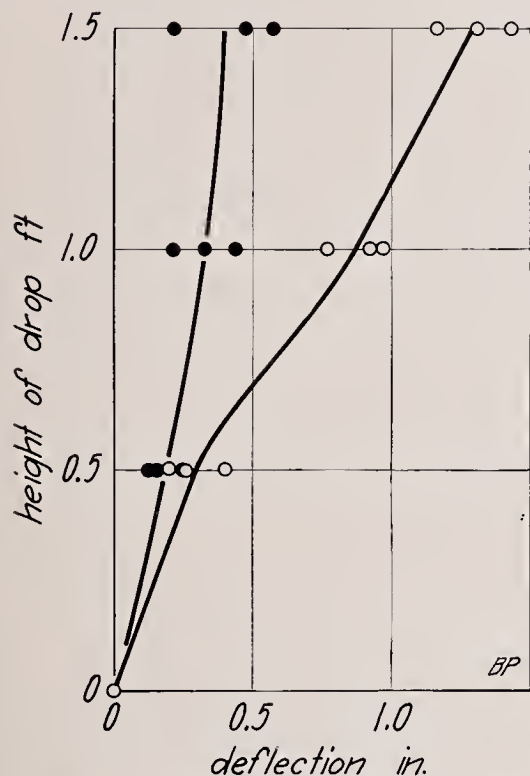
FIGURE 35.—Impact load on wall BP.

Height of drop-deflection (open circles) and height of drop-set (solid circles) results for specimens BP-P1, P2, and P3 on the span 7 ft 6 in.

At a drop of 0.5 ft the bond between the mortar and the concrete blocks in each specimen ruptured at a bed joint near midspan. At the maximum drop each specimen failed by opening of the cracks.

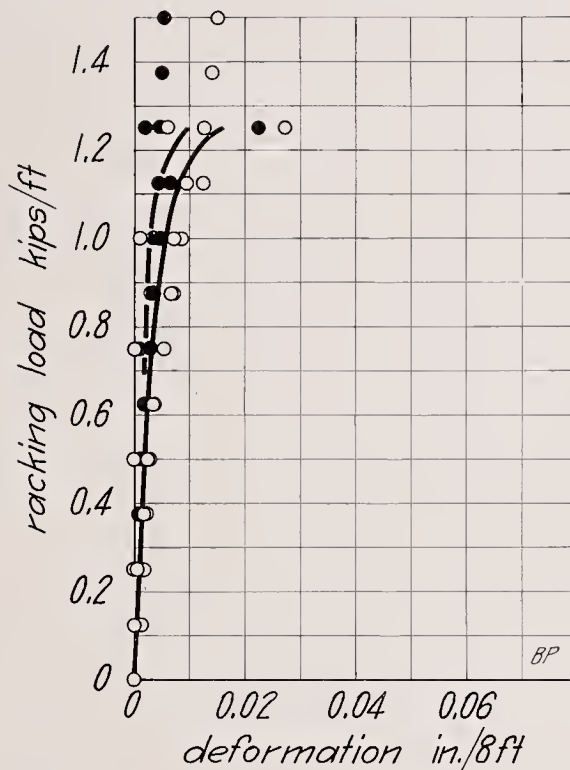
FIGURE 36.—Racking load on wall BP.

Load-deformation (open circles) and load-set (solid circles) results for specimens BP-R1, R2, and R3. The loads are in kips per foot of actual width of specimen.

The results for *BP-R1*, *R2*, and *R3* are shown in table 7 and in figure 36.

The deformations and sets shown in figure 36 for a height of 8 ft were computed from the measuring-device readings. The gage length of the measuring device was 6 ft 10½ in.

At loads of 1.47, 1.25, and 1.62 kips/ft on specimens *R1*, *R2*, and *R3*, respectively, each specimen cracked through the bed and head joints diagonally from the loaded corner to the stop. At the maximum load each specimen failed by rupture of these joints and, in specimen *R3*, by rupture of the bed and head joints along another line diagonally from the loaded corner to the stop. In addition, two concrete blocks broke in specimens *R2* and *R3*.
